Clinical

Anterior restoration with tissue-level implants

Olivier Benhamou discusses a post-extraction implant restoration case, where he opted to use zirconia collar tissue-level implants to ensure a highly aesthetic result

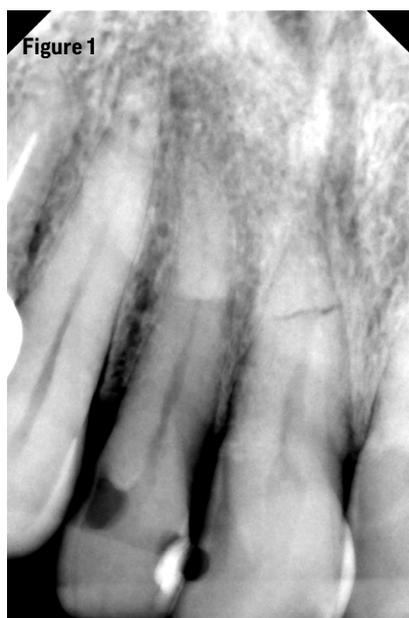
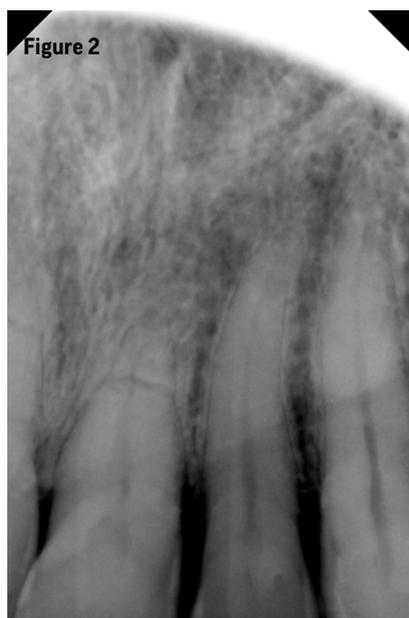
Figure 1

Figures 1 and 2: Fracture of the maxillary incisor

A female patient presented with significant damage to her maxillary central incisors; she had tripped while alighting from a bus and hit the street, fracturing the teeth at their roots. The initial X-rays that were taken (Figures 1 and 2) show the extent and location of the trauma. Other than the damage to the teeth – and minimal injury to her lips and gum – the patient was of good dental health and an ideal candidate for implant restoration.

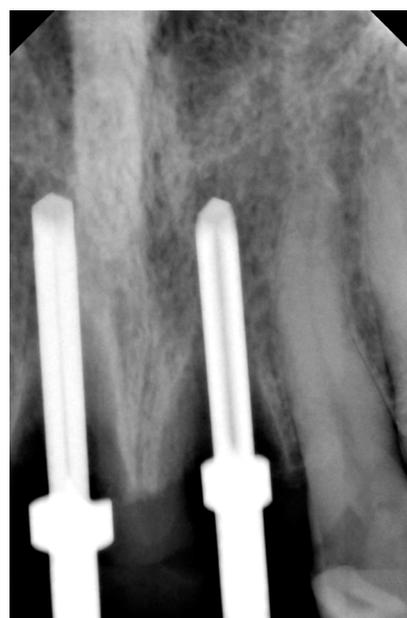
Figure 3: Angulation and direction of cavity preparation

anchorage. At this stage, another radiograph was taken (Figure 3) to ensure that the direction and angulation of the drill was correct.

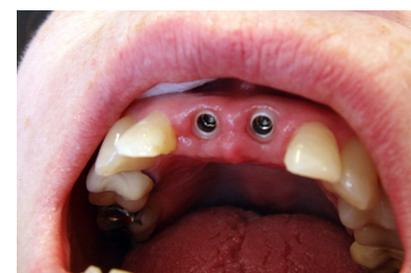
Figure 4: Zirconia emergence and soft tissue healing

In this case, it was possible to place the Z1 implant a little lower into the gum (Figure 4) to help encourage better soft tissue healing, maintain the interdental papilla and improve final aesthetics. A cover screw was used, rather than a healing screw – thanks to the design of the implant itself (Figures 5 and 6).

Due to the biocompatibility of the Z1's zirconia emergence, however, the soft tissue attachment is immediate and very strong, making it possible to close the wound quickly without the use of sutures. The implant's emergence diameter also ensures that gingival volume is maintained, the crestal bone is protected and the risk of bacterial infection during the healing process is eliminated.

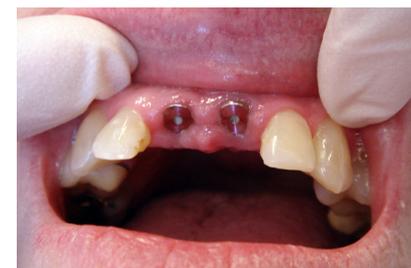
Figure 6: Cover screw and soft tissue regeneration

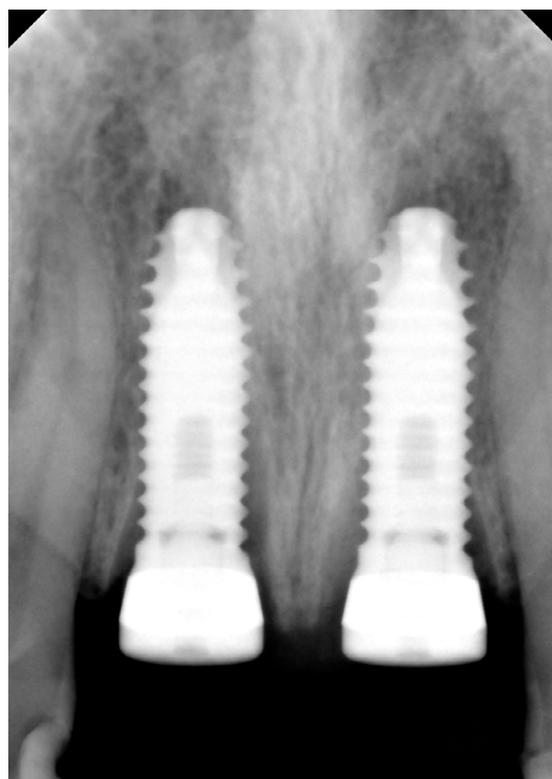
Figure 5: Z1 in situ with cover screw

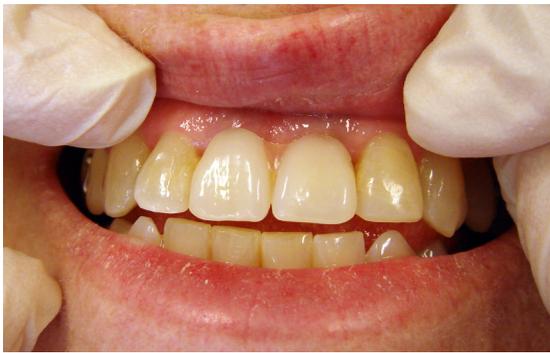
Due to the nature of the initial injury, it was decided to allow the bone and implant site a full three months to heal. This meant that the patient would need to be fitted with a temporary denture (Figure 7) for the duration of the recovery time. This was carefully attached so as not to touch the implants' cover screws, giving the implant as much time as possible to heal and osseointegrate.

Figure 7: Temporary partial denture

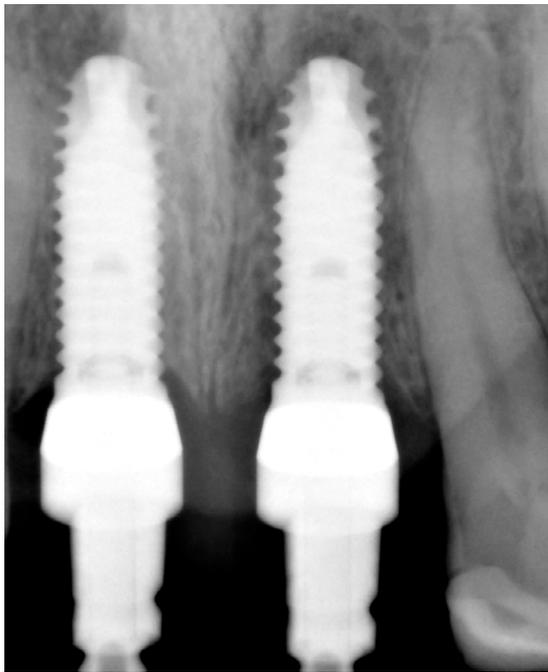
An indirect transfer impression was used for the crowns (Figures 8 and 9). In this case, it was decided that each implant would be fitted with a separate crown rather than one conjoined restoration, regarding long-term maintenance and assurance. Indeed, should something happen to the implant 15-20 years into the future, it would be easier to manage just one tooth rather than a fused crown.

Figure 8: Pop-in transfers in situ

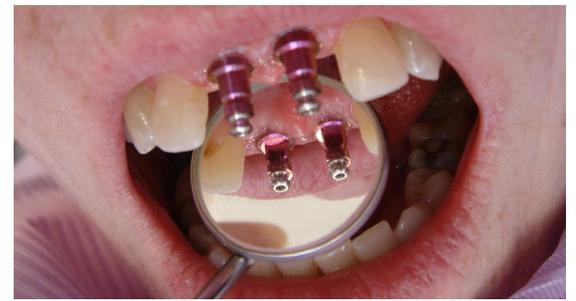
Figure 9: Pop-in transfers in situ

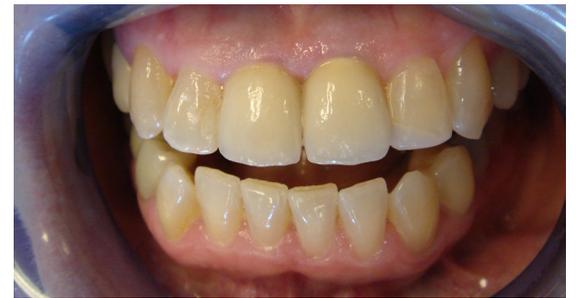
Each of the two crowns (Figure 10) were a composite of

metal and ceramic materials, which provided a great deal of mechanical functionality as well as a highly aesthetic outcome. They were also cement retained – a process that is made significantly safer, more aesthetic and easier due to the Z1's zirconia ring. Since the presence of excess cement can contribute to inflammation, infection and even implant failure in the long term, the removal of excess cement is imperative and easier thanks to the zirconia shield.

Figure 10: Final restorations
